TITLE: Industrial Case Histories

TITLE: New Frontiers in Integrated Diagnostics and Prognostics.  
Proceedings of the 55th Meeting of the Society for Machinery Failure  
Prevention Technology. Virginia Beach, Virginia, April 2 - 5, 2001

## **Industrial Case Histories**

**Kevin R. Guy**

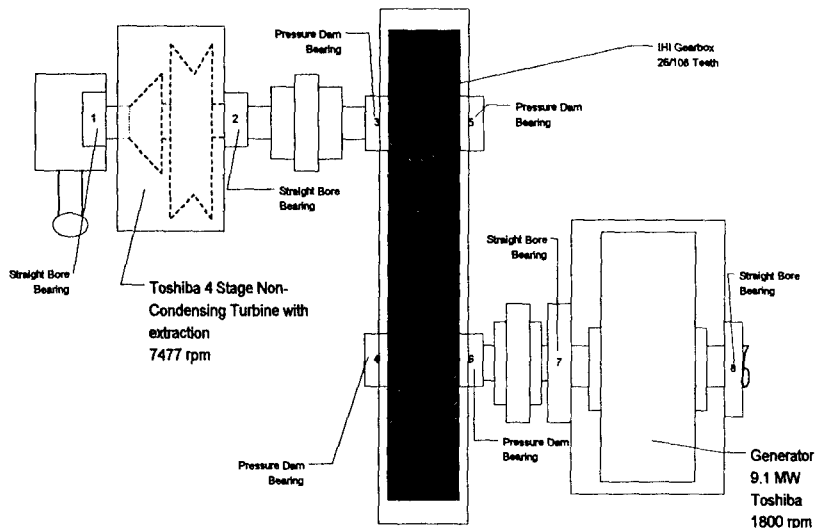
Figure #1

**Problem:** This unit was repaired after suffering catastrophic shut down during a hurricane. The turbine is owned by a government utility on a small island nation in the West Indies. The utility had utilized diesel generators until a far eastern country built their first steam plant. The utility ran into problems during Hurricane Hugo. Operations personnel not being experience with steam turbine failed to maintain the DC battery system. When the storm struck the island; the electric distribution system was destroyed causing the turbines to trip. The turbine generator train (Figure #1) went from operating speed to a dead stop in 45 seconds without lubricating oil. The turbine journals and bearings were destroyed. The bearings in the gearbox and generator were also completely wiped; however, there was no damage to the shaft journals.

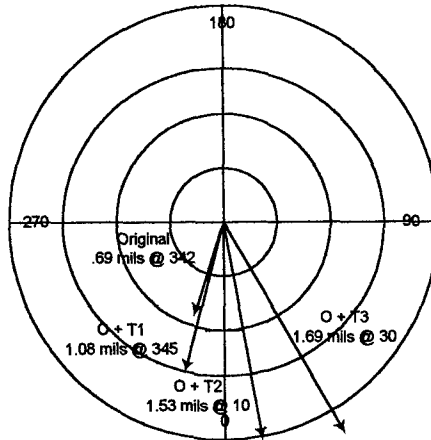
Figure #2

**Test Data and Observations:** Balance data was collected with a tracking filter and the analysis was performed with a Hewlett Packard Dual Channel FFT Analyzer. Velocity sensors were used throughout the balancing and analysis. Because no previous balance data was available; it was decided to perform a measured effect balance. This balance method was both ineffective and inclusive (figure #2).

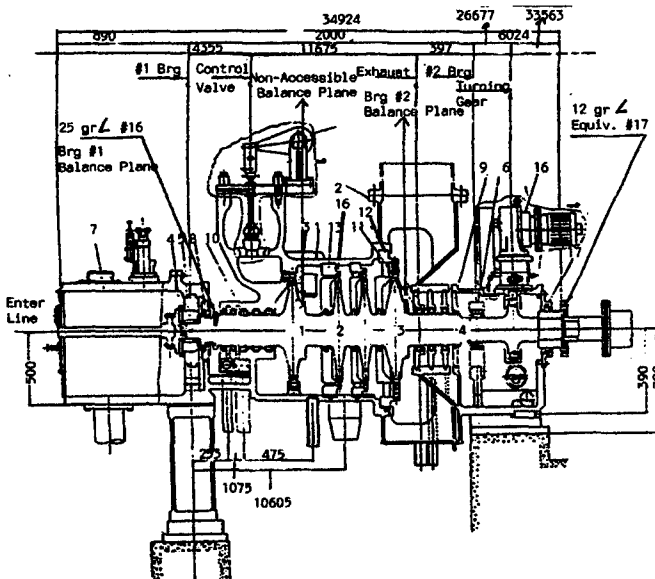
Figure #3

Since the effect was fairly decent, it was decided to again try a measured effect balance in conjunction with a four run no phase balance method. This proved to also be fruitless. Looking over the turbine schematic (figure #3) it was determined the #1 balance plane was too far from the center of the rotor (first mode) balancing on the #1 bearing balance ring.

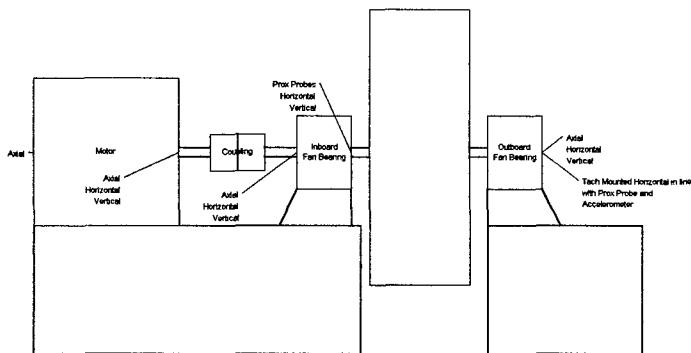
Figure #6

Some initial data collected by the Cement Plant indicated there might be a natural frequency close to operating speed. The fan utilizes straight bore sleeve bearings and operates at 1196 rpm (19.94 Hz). The motor has been replaced several times and due to these replacements the motor and fan pedestals have been modified extensively.

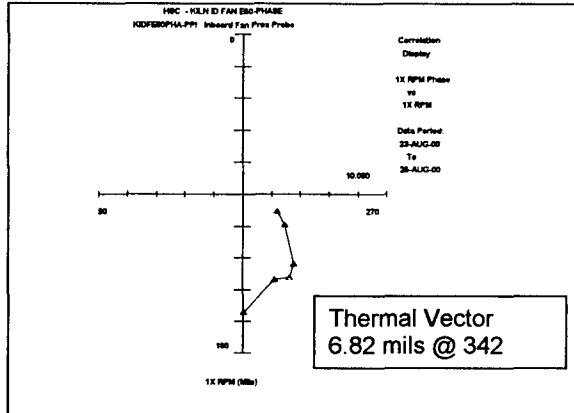
Figure #7

Phase and amplitude data showed thermal vectors as high as 6.8 mils (Figure #7). Coastdown data indicated the vibration dropped off almost immediately as the power was cut (Figure #8). This is a definite indication the fan is running very close to a natural frequency. In 52.5 cycles, the shaft vibration drops by over 76%

**Corrective Action:** Due to the past history of balance problems with the turning vane, it was recommended to removed it. Also, recommended was to balance the fan with prox probes. The shaft vibration was 1.5X to 2X higher then the casing vibration. All previous balancing was only performed with seismic readings.

Improving the balance condition would lower the thermal effect due to the temperature extremes incurred from start-up to normal operating conditions.

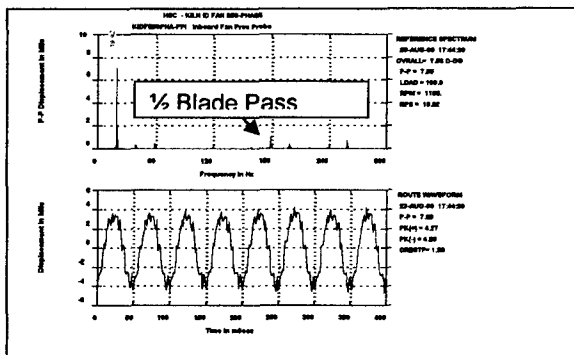
Figure #9

One other item that showed up in the vibration data collected during operation was the presence of a  $\frac{1}{2}$  X of blade pass (figure #9). When an orbit analysis was performed this  $\frac{1}{2}$ x of blade pass also was present.

Finally the 1/2 Blade Pass was caused by a force on the fan wheel generated by the turning vane.

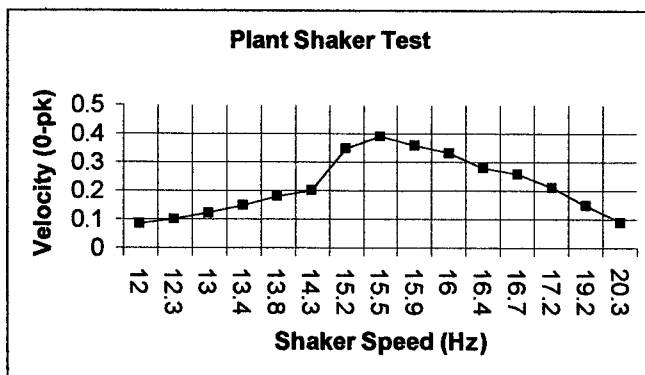
Figure #11

**Symptoms:** Plant personnel had performed a shaker test on the "A" cell and found vibration response was high in the 15 - 17 Hz range (Figure #11). The dominant vibration frequency from the data plots (motor to gearbox) is blade pass. This is found in the axial, horizontal and vertical directions. Once the review of the past data was completed a test plan was developed.

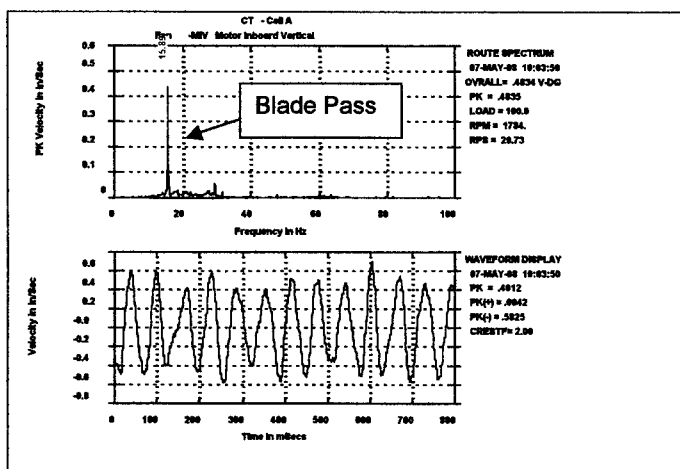
Figure #12

**Test Data and Observations:** A complete set of vibration data was collected with a dual channel data collector (Figure #12). Impact tests were performed with a dual channel FFT analyzer. A three (3.0) pound instrumented hammer was used for excitation. Along with the impact tests; another set of shaker tests were performed throughout the support structure of the motor, gearbox and fan system (Figure #13).

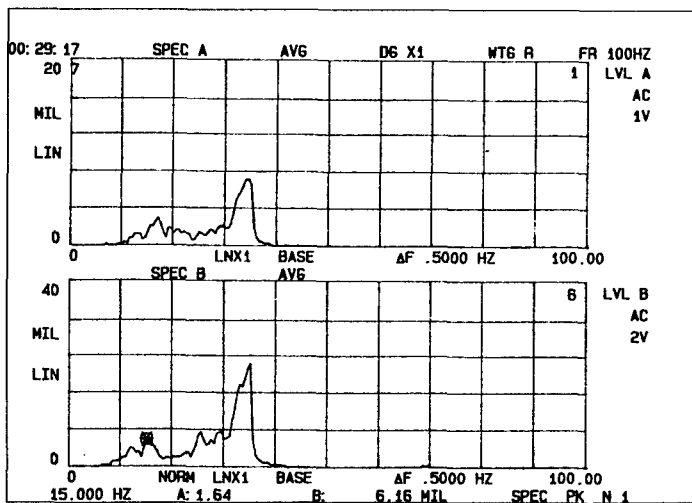
Figure #13

The Shaker tests indicated distinct natural frequencies around blade pass Figure #13). The amplification (Q Factor) from the tests were from 5.3 to 10.5 plus. Impact test (Figure # 14) and Shaker Test results can be found in Table III.

**Corrective Action:** The data definitely indicates a natural frequency excited by the blade pass frequency of the fan. The vibration problem being experienced is caused by the six blades on the fan exciting the natural frequencies.

The natural frequency of a system is based on the mass and stiffness of the system. No one component is usually the fault; but, rather all the components of the system tied together cause the problem. Breaking the system up (detuning) by placing a neoprene material between the joints of connected parts may break the system up and eliminate the problem, however, this may or may not work. The final step would be a redesign of the system by replacing the six blade fan with a fan of five or seven blades.

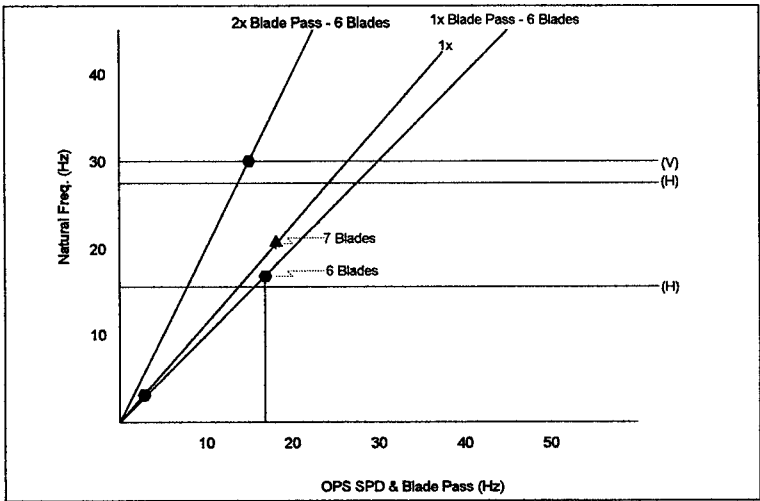
Because this is a natural frequency problem the solution is to remove the forcing function which is the blade pass. Figure #15 shows an interference diagram for the different pieces of the system tested by impact hammer and shaker. The plot clearly shows that a seven blade fan operating at 2.65 Hz will have a blade pass frequency that will fall between natural frequencies and will have little or no excitation from the blades.

Since the fan has operated for so long (over eighteen months) with high vibration and no significant problems have been experienced the best option maybe to run as is and not change anything in the system. Based on the fact that no serious problems have occurred in the present condition the recommendation was made to run the cooling tower without any modification. If problems arise in the future; Febreeka should be placed under the gearbox and motor to detune the system,

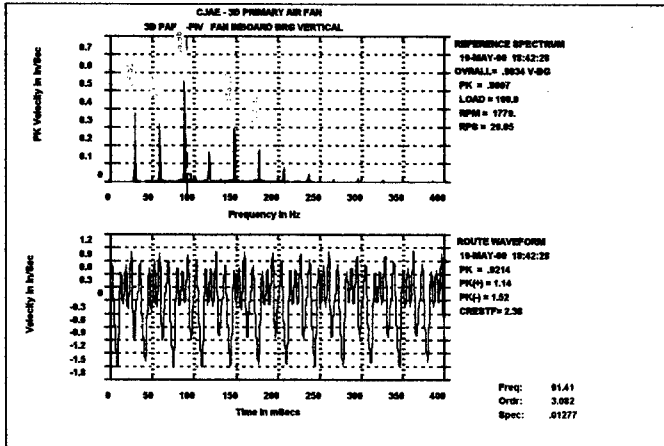
Figure #17

**Symptoms:** The symptoms remain consistent. The spectrum shows multiples of 1X and the timewave shows clipping (Figure #17).

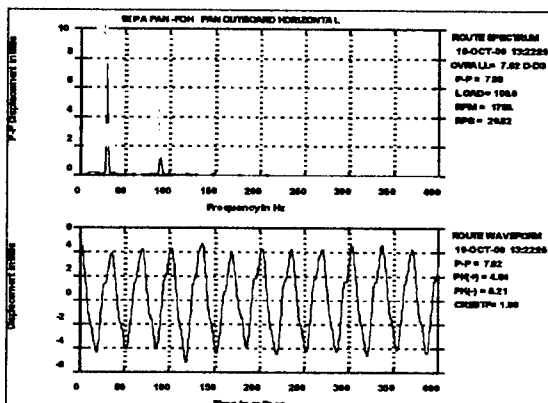
Figure #18

**Test Data and Observations:** This unit is on a monthly monitoring schedule; so it's easy to see when problems are developing. Once the looseness is apparent, the adjustment nut on top of the bearing has become loose. This nut is tightened down until the looseness is eliminated. This unit went through several cycles of the bearing nut becoming loose and having to be readjusted. The day after the last adjustment the bearing (outboard) closest to the fan failed. Failures of this nature have also occurred in the past. The failure required the bearing liner and bearing housing to be replaced. Data collected immediately after the fan was put back in service indicated the fan needed to be balanced (Figure #18).

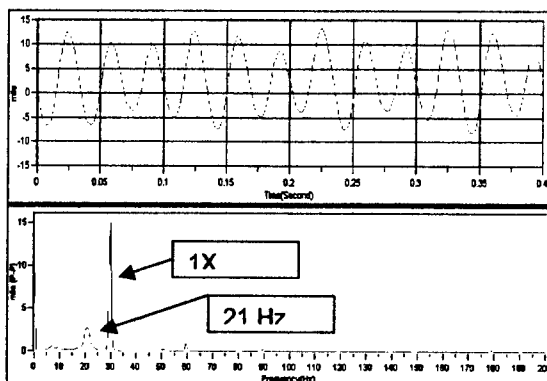
Figure #20

Prox probes were externally installed to read the shaft vibration between the bearings. Shaft vibration amplitudes (Figure #20) were still 15.0 mils (pk-pk) plus.

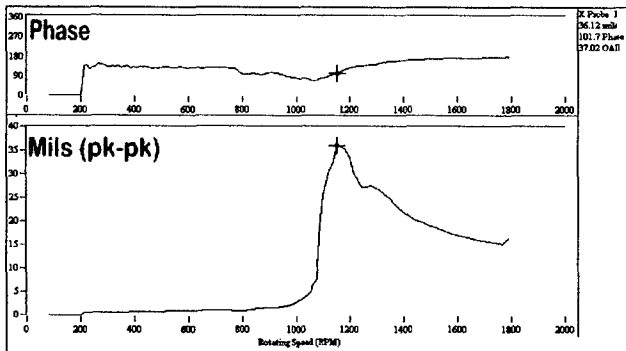
Figure #21

Also, the data showed a frequency at 21.0 Hz (1260 cpm). It was decided to collect a bode plot on a coast down (Figure #21). The bode plot shows a critical speed just below 1200 rpm. It should also be noted it appears the fan rolls off a critical as soon as the power is cut.

**Conclusions:** The long term problems experienced with these fans are the result of bearing design. Balancing with seismic data was fruitless because the bearing liner is not in contact with the bearing housing. The bearing liner rests on a vertical support that has no horizontal support even though the bearings are held in place by the torque nut at the top of the bearing cap. The overhung design of the fan puts no load on the inboard bearing. This is evident the inboard bearing rarely needs changing and seldom shows any wear pattern.

**Corrective Action:** Since this plant has six fans that behave this way, all the fans will be balanced using prox probe readings. It was recommended to perform an in-depth analysis of the fan bearing - pedestal system. A modal analysis of the fan movement in the axial, horizontal and vertical directions will be performed. Impact tests of the shaft and bearing caps will be done for validation of a rotor dynamic computer model of the shaft and bearing system.

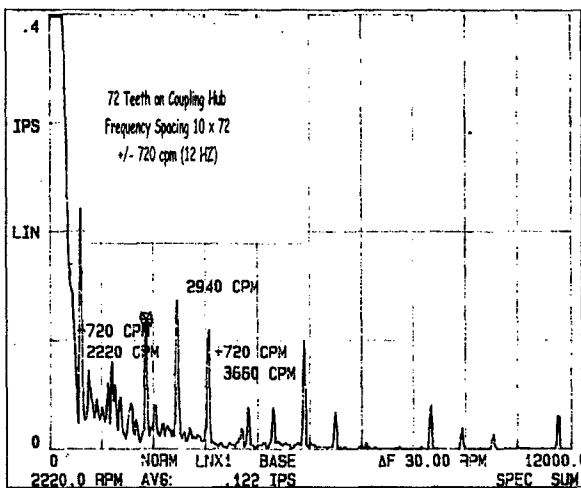
Next vibration data was analyzed from the turbine. Figure #23 is the outboard end of the turbine. The data is take off the shaft riders installed on the TSI system. The data shows ratty sub synchronous vibration. The peak amplitude at 2940 cpm has side bands at + and – 720 cpm. The 720 frequency is ten times

the number of teeth on the coupling hubs. It was concluded from this data that the pump and coupling both had serious problems.

**Results:** The coupling inspection found severe wear and it had to be replaced. The thrust check found the pump had severe wear and would have to be rebuilt. This pump had been in operation over eleven years and was the last original pump in the plant. The coupling had been in service for at least seven years and may have been the original.

**Corrective Action:** It was recommended that the unit be shutdown and the coupling be inspected for wear. The total thrust of the pump was also to be measured. This would indicate if the pump and coupling were the problem or if further analysis would be required.

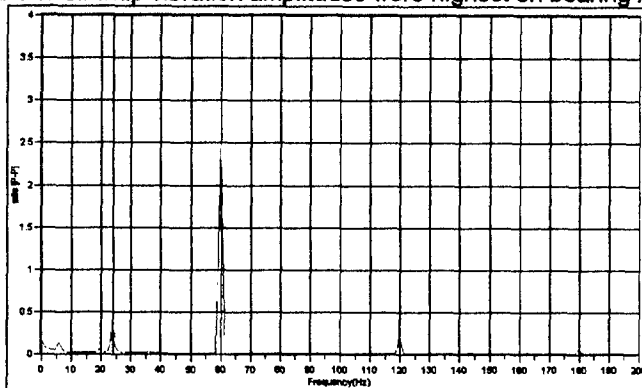
Figure #26

When this problem developed at 90 megawatts the oil temperature was at 105 degrees Fahrenheit. It was decided bring the unit back to 90 megawatts and raise the oil temperature from 105 degree F up to 110 degrees F. As the oil temperature was raised the subsynchronous vibration dropped. A three degree F temperature rise effected the subsynchronous vibration (Figure #26).

**Conclusions:** The oil whip problem was a combination of two factors. First the unit had not grown into alignment. This unit is aligned so that bearing #3 is loaded heavy during the start up. This is done because it is susceptible to whirl and whip conditions. The oil being cold and the unit not having grown into alignment allowed the whip to develop. Since this problem; questions have arisen about the alignment of this unit. Optical alignment data shows that bearing #3 may be unloaded. The alignment procedures used during the outage have also been brought into question.

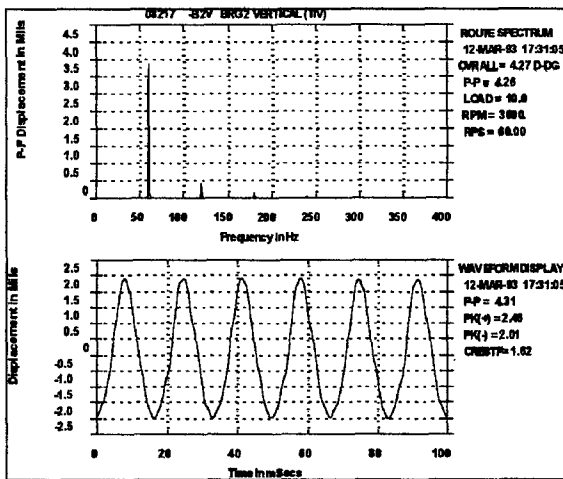
Figure #28

**Test Data and Observations:** Test data collected by the plant personnel indicated the vibration was at 1X (Figure #28).

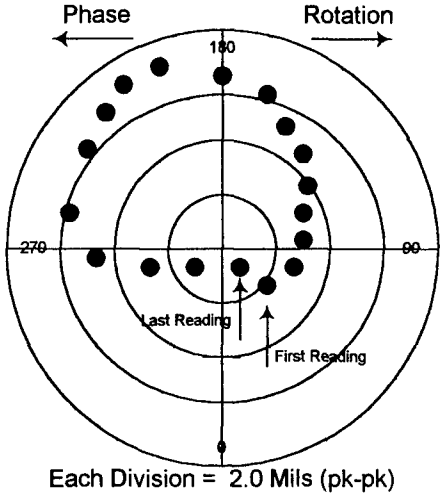
Figure #29

To get a better picture of the cycling of the vibration 1X amplitude and phase data was collected every five minutes for 90 minutes. This showed the vibration was moving opposite rotation over time (Figure #29).

Phase movement with 1X vibration is an indication of a rub. When the unit was at a low cycle of vibration an attempt was made at running the unit at full load. Vibration spectra data was collected on bearing #3 to see what the cause of the erratic vibration was. When the unit reached 20 megawatts a subsynchronous vibration appeared (Figure #30).

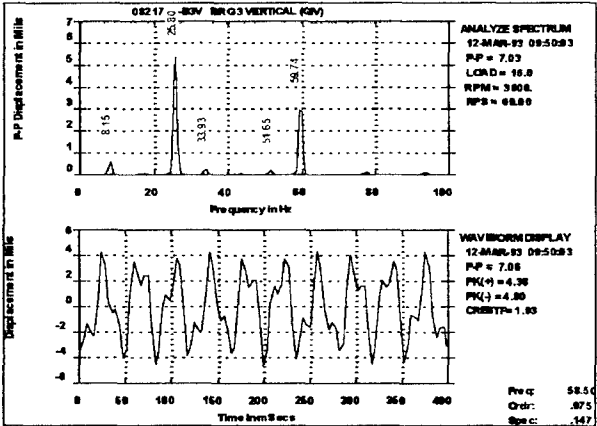
Figure #30

**Results:** It was found that during the calculation of alignment settings a dial indicator was read incorrectly. This resulted in the generator being set too low unloading the first generator bearing. In turn, bearing #2 was rubbing due to the seal clearances being closed up.

**Corrective Action:** It was recommended the alignment setting be verified and changed as necessary to relieve the situation. This needed to be done as soon as possible; because the plant generated its own power and could not run at full production without the turbine.

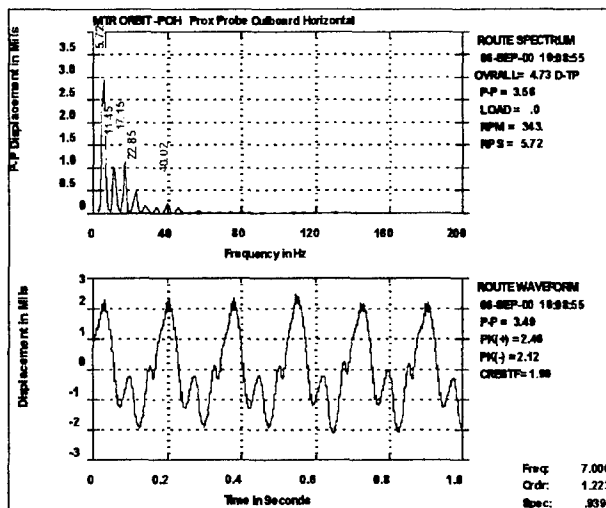
Figure #31

**Test Data and Observations (1):** All initial test data was collected with the motor uncoupled from the pump. Because of the sudden vibration trips when the excitation is at an excitation of 39 Hz to 40 Hz, data was recorded to determine the cause of the vibration. Data was collected from both the installed proximity probes and extra mounted seismic sensors. Trying to minimize the problem with tripping, vibration data was collected at 5 Hz to 10 Hz excitation intervals. Since the data was primarily 1X, Plant personnel and equipment vendors wanted the motor balanced (Figure #31).

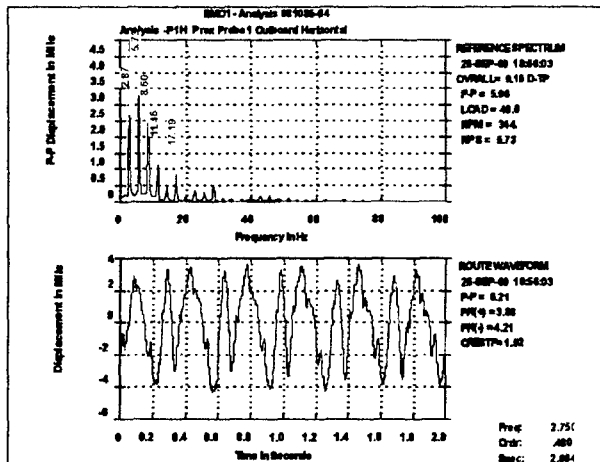
Figure #34

The subsynchronous vibration at 2.37 Hz is 47% of running speed (Figure #34). The subsynchronous vibration was only present on the outboard motor bearing. This vibration would only appear when the unit was at 40 Hz excitation and above. Below 40 Hz excitation this vibration was not present. It had been noted during the balance runs; a subsynchronous vibration was present; however, in amplitudes below .2 mils (pk-pk).

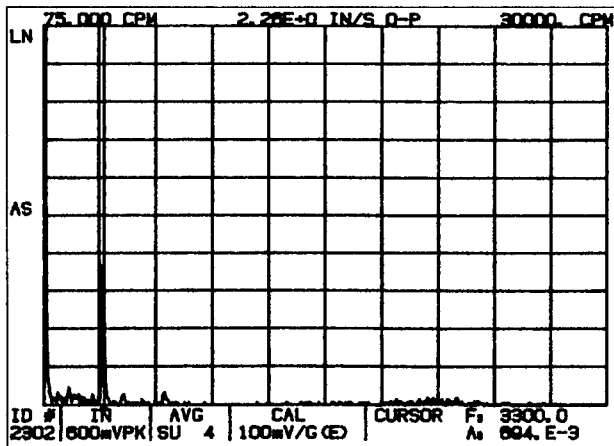
Figure #35

With the operating speed on the pump at 4350 rpm a subsynchronous vibration is present at 3225 rpm (Figure #35); the running speed vibration is non-existent. Only the sub-running speed vibration is present. The subsynchronous vibration at 74-78% of running speed indicates hard, continuous contact between the rotating and stationary parts of the pump.

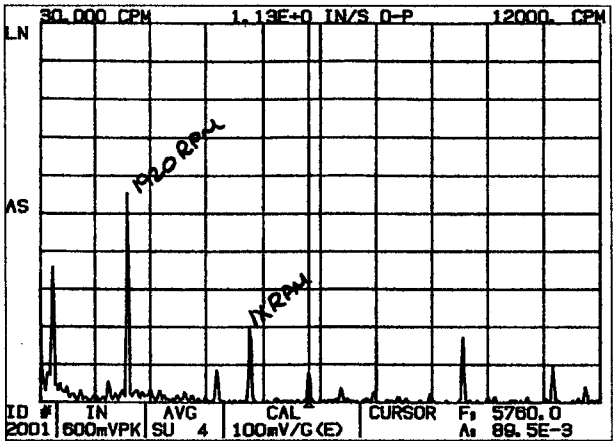
Figure #36

**Test Data and Observations (2):** Since the pump was just overhauled, our first thought was the turbine vibration was the result of some procedure done during the overhaul; even though the vibration was in the turbine and not the pump. Because this is a capability related piece of equipment, it was recommended that we go into a two part analysis program. First, a decision was needed to determine, if the pump could be used for operational needs; second, find the cause and solution to the problem. Before any decisions were made, a full set of data was collected to determine if the unit could be run without severe damage. Spectrum data shows approximately 7.9 mils of subsynchronous vibrations present at 1920 rpm and 3840 rpm (Figure #36).

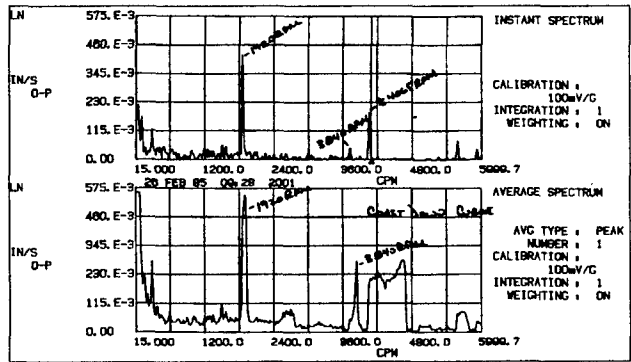
Figure #37

Next, the turbine was brought up to 4700 rpm. Coast down curves (Figure #37) in peak average (Bottom Plot) were going to be plotted vs. instantaneous spectrums (Top Plot) to determine the speed this whirl develops. This data plots the vibration with the turbine running 4065 rpm. Note the subsynchronous vibration is present at 1920 rpm and at 3840 rpm.

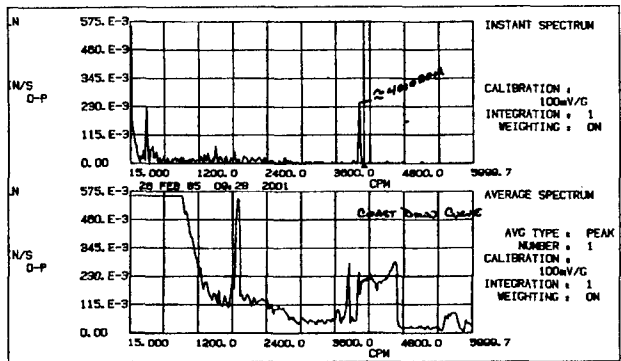
Figure #38 shows the vibration with the turbine running at 4010 rpm with no subsynchronous vibration. This indicates that the factor causing this vibration is not present until the turbine is in the last 20% of its speed range, the point at which steam flow is the highest.

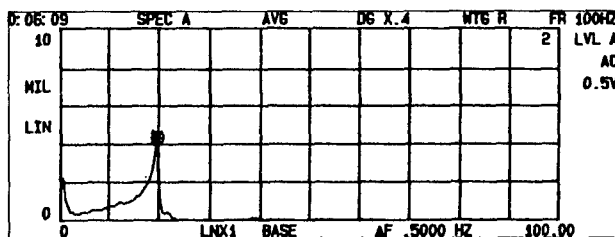
Figure #41

Operating data showed the majority of the vibration to be in the horizontal direction and a drastic drop in vibration as the motor speed lowered from full speed operation (Figure #41). The vibration amplitude drops 3.0 mils in 2.0 Hz.

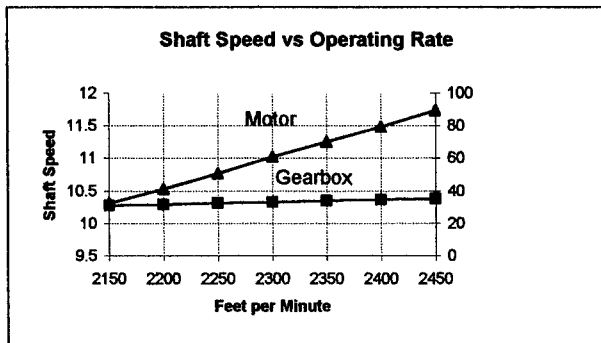
Figure #44

Production personnel noticed floor vibration when the mill was operating at 2350 feet per minute (fpm). A plot of motor speed versus mill operating speed is in figure #44.

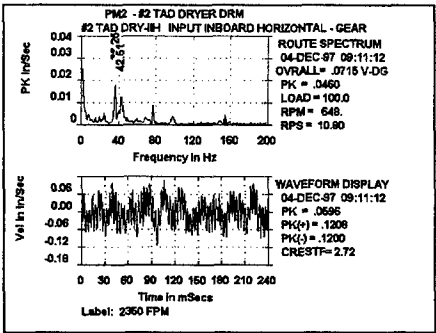
**Results:** The equipment supplier designed isolators and snubbers on the gearbox to help relieve the vibration caused by the natural frequency. Figure #48 shows data after the isolators and snubbers were installed.

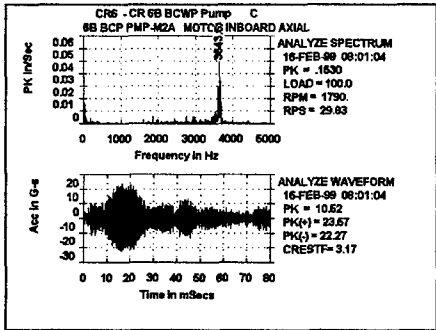
Figure #49

**Symptoms:** Vibration trend data showed a high frequency vibration at 3643.6 Hz (Figure #49). The overall amplitude of vibration had been trending up over the past several months.

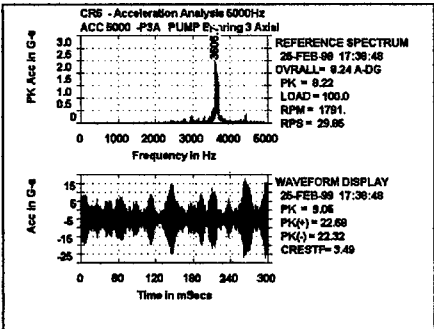
Figure #52

The new plots with the longer time data shows the bursts of energy are at 1X (Figure #52). Looking at the same point in Velocity (Figure #53) shows essentially the same information as figure #2; 1X and a subsynchronous vibration between 5.0 and 6.0 hertz. None of the velocity or Acceleration plots indicate any bearing frequencies. The time data is typical of bearing frequencies; however, no distinct frequencies can be identified. Since the goal of this analysis was to identify if the problem was a pump or motor bearing it was decided to try peak view analysis. The peak view data plots showed two distinct bearing problems on the thrust bearing in the pump (Figure #54).
